Ford Details Proper Roof Panel Repair (Part 1 – Removal)

This specific vehicle repair—**Section 501-28: Roof Sheet Metal Repairs, Removal and Installation**—is found in the official Ford Workshop Manual, located on [Motorcraftservice.com](#).

Official Repair Procedures: 2018 Ford Expedition Finish-Panel Repair & 2017 Lincoln Continental Head Up Display Module

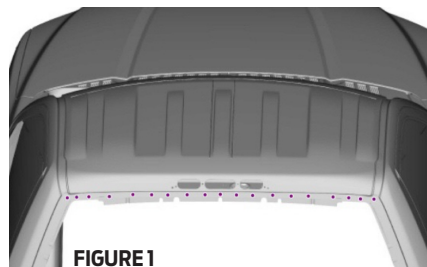
FIGURE 1

Following the workshop manual procedure, the original roof ditch sealer is removed, using a hot air gun and scraper. The SPR rivets at the front and rear of the original roof skin are then removed (**Figures 1 and 2**).

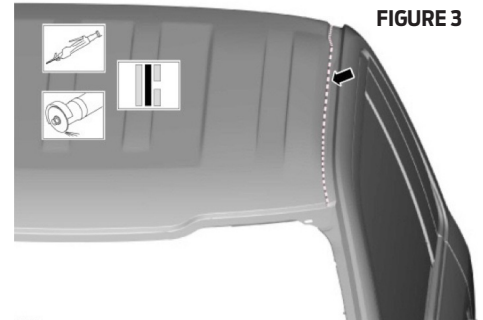
FIGURE 3

The next step directs where to cut the roof (inboard on the roof ditch), noting it must be done to the outer panel only, using the air body saw and spherical cutter (**Figure 3**).

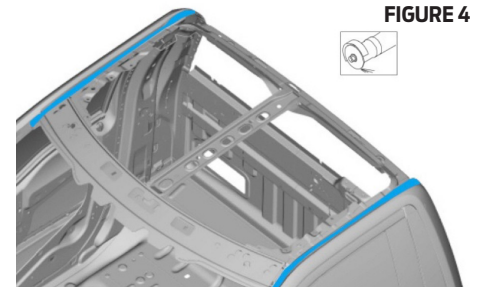
FIGURE 4

Using a grinder or air-chisel, carefully remove the remaining portion of the roof panel flange and laser-weld bead (**Figure 4**). Technicians are strongly advised to use caution to avoid thinning the metal in this area.

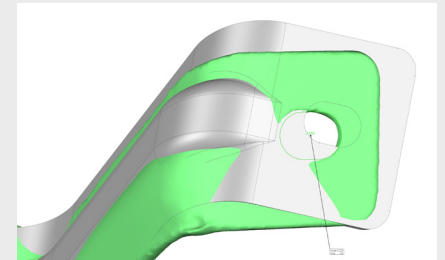
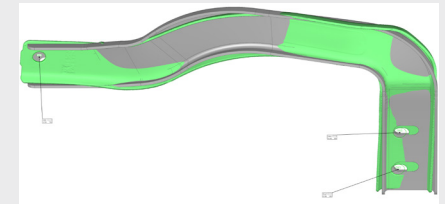
The laser scans show significant deviations from the specifications regarding guide-hole locations and length, as well as fluctuations in the curvature of the bracket wall in numerous locations (green areas).

Ford Motor Company asked an independent test lab to determine whether aftermarket copy versions of F-150 parts frequently replaced in a collision repair would meet Ford dimensional design specifications. The lab conducted laser scans of aftermarket front bumper brackets and a chrome front bumper for the 2012 F-150, and similar to the results of the aftermarket aluminum hood detailed in the last issue of *On Target*, the copy parts did not meet Ford specifications.

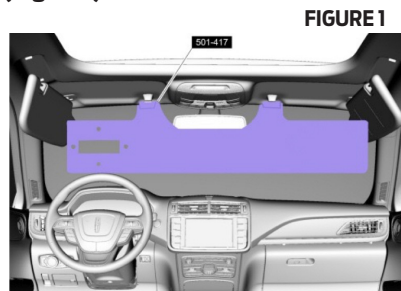
FIGURE 1

5. Install the HUD eye box inside the vehicle. The HUD eye box should be placed on the dashboard directly behind the windshield (similar to how a sun visor would be placed) (**Figure 1**).

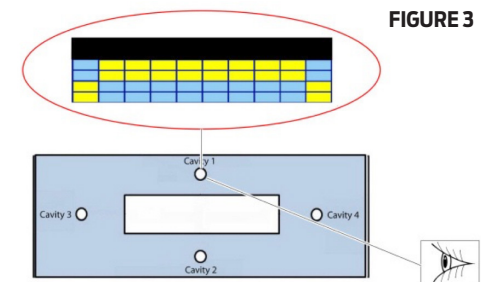
FIGURE 3

8. Adjust the alignment grid, using the UP/DOWN/OK button on the steering wheel, while viewing the grid through Cavity 1 in the HUD eye box until the top two grid lines are not seen (**Figure 3**).

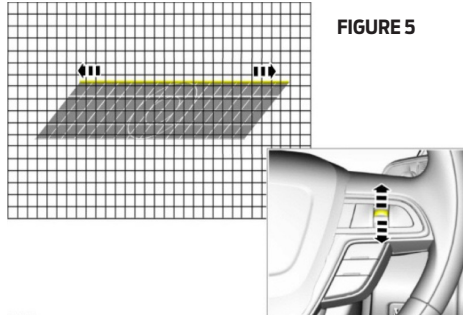
FIGURE 5

16. Using the Up and Down button, remove the horizontal distortion from the image (**Figure 5**). Press OK to save the adjustment. Press Return to exit to the previous menu.

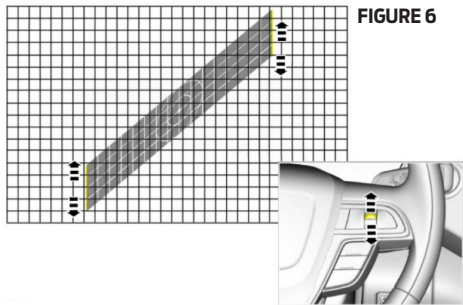
FIGURE 6

17. Select Vertical Distortion menu and press OK. Select Trapezium. Determine if vertical distortion is present. If vertical distortion is not present, select OK and skip to step 20.
18. If vertical distortion is present, identify the category of the most severe distortion present in the displayed image (similar to identifying horizontal distortion).
19. Using the Up and Down button, remove the vertical distortion from the image (**Figure 6**), then press OK.

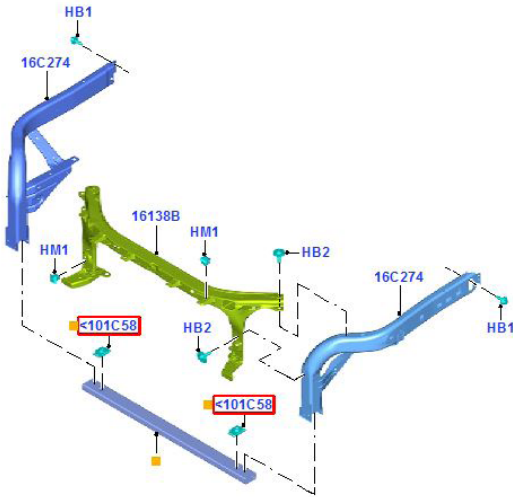
Front Apron

■ = 16138A

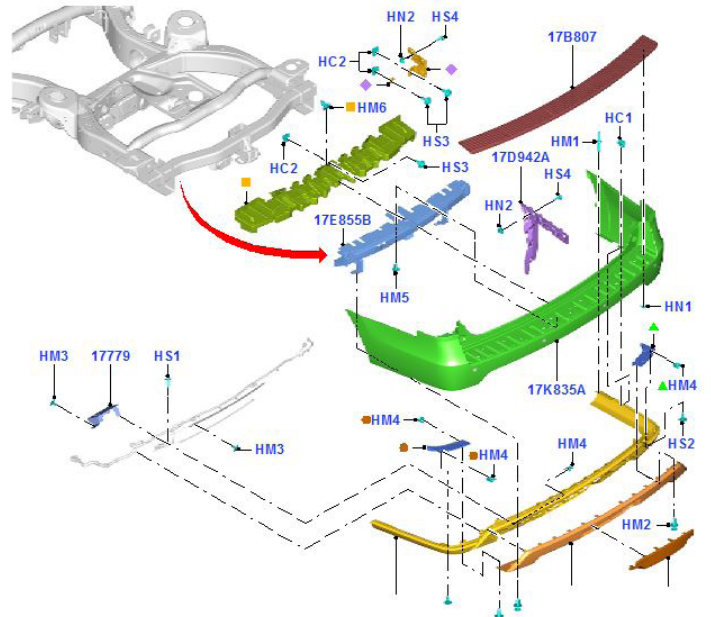
Rear Bumper

■ = 17E855A
 ▲ = 17B861
 ● = 17B862
 ◆ = 17D942B
