# On Target

For Ford and Lincoln wholesalers  
and the collision repair industry

## More Details on New Ford Explorer® Sectioning Repair Option

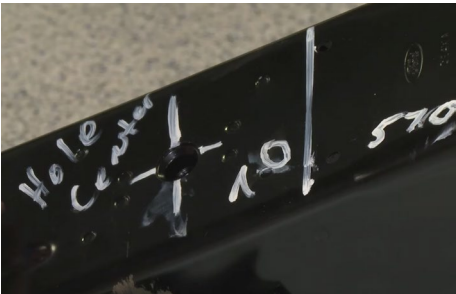
**Figure 3** Repairer Anton Verwijst utilized the center of the cradle-bolt hole as a fixed reference point to obtain an additional measurement moving toward the back of the vehicle.

In this case—Verwijst used the center of the cradle-bolt hole, the exact same location that informed the maximum length of the sectioned repair—as his fixed point to obtain this measurement.

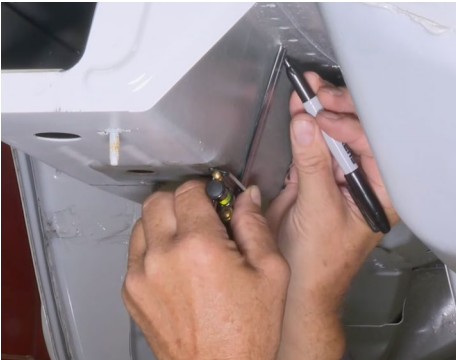
**Figure 5**

Another helpful tip provided by Verwijst is to put a piece of masking tape on the measuring tape to help transfer the cut line to the damaged area on the vehicle. Verwijst cautioned to ensure you make your mark on the correct side of the tape and noted you can put arrows on the tape to indicate which side of the tape to draw the cut line.

Verwijst emphasized to measure several times and re-check your work multiple times prior to cutting as you don't want to make a mistake that could require an entire new replacement frame rail. He also noted that he finds it helpful to draw an entire cut line on all three sides of the rail instead of just cut marks as it helps to steady the cut.
